# *Blue Star Real Estate Inspection Services*

## Property Inspection Report

123 Blue Star Street, Any city in, Tx 78888

Date of Inspection: 8/3/2019

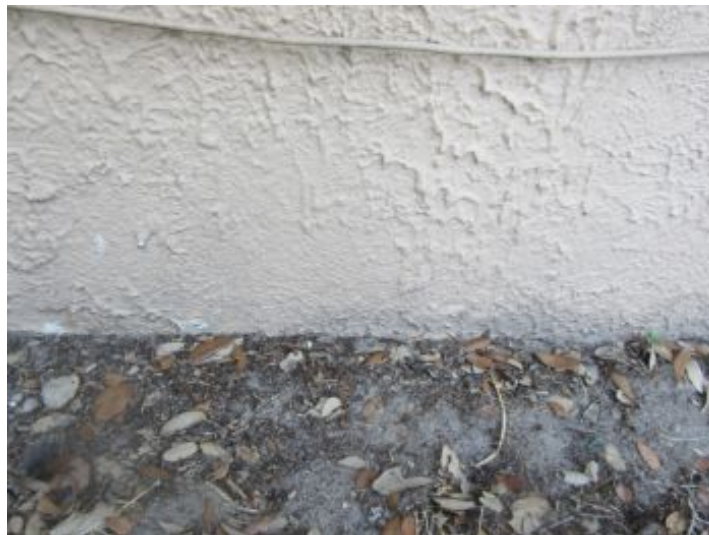
- Grade was observed to be too high in areas around the perimeter of the foundation. A minimum of 4 inches should be maintained between grade and bottom of stucco in all areas.
- Visible minor erosion and grade depressions observed around perimeter. Grade should slope away from the foundation at a minimum of 6" in a 10' span.

*High grading*

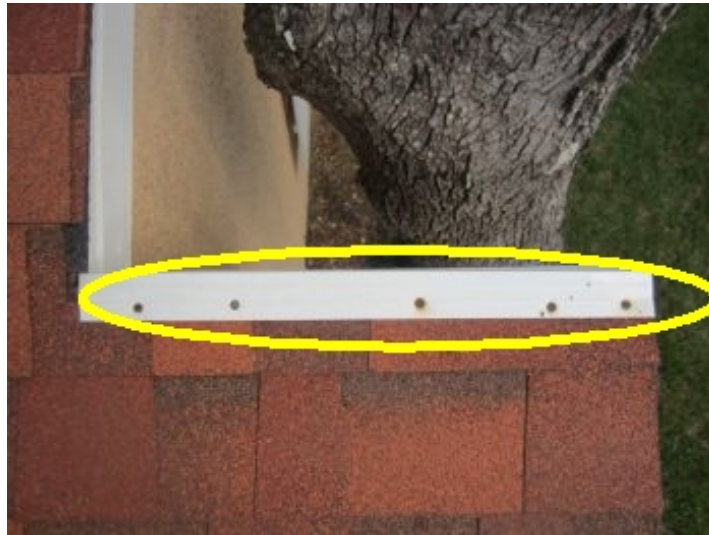
- Roof appears to be fairly new
- Some exposed nail heads were observed at various locations creating possible water penetration locations. Nail heads should be sealed with roofing tar when covering with shingles is not possible.

*Exposed nail heads*☒ ☐ ☐ ☒ **D. Roof Structure and Attics**

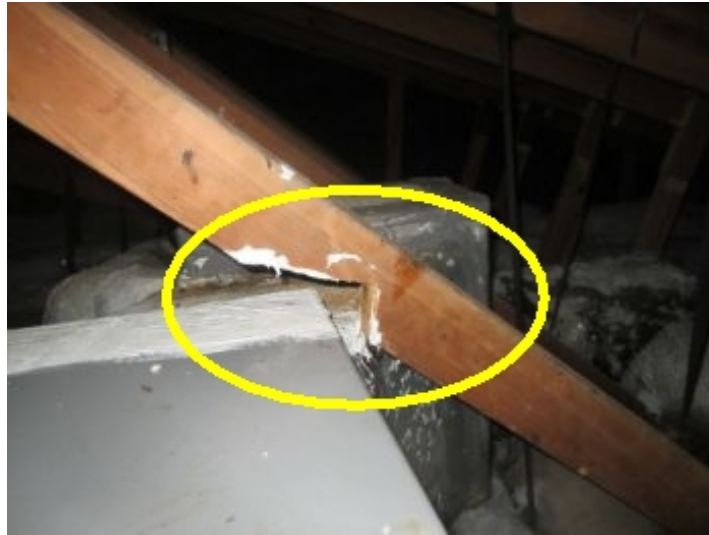
- Roof trusses have been cut or altered, this may compromise the integrity of the structure. We recommend review by a licensed structural engineer for evaluation and repair or replacement, as necessary, prior to close.

*Excessively notched truss in attic at AC unit*

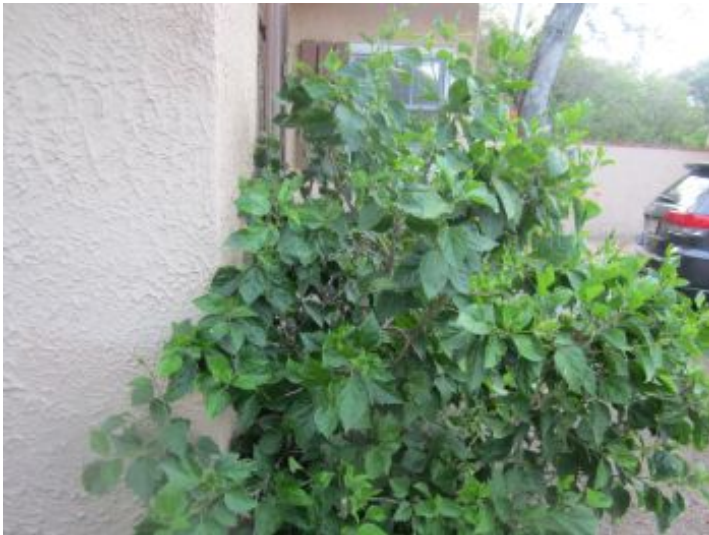
- NOTE: The heavy foliage growing on, over or around the exterior walls of the structure should be trimmed back at least {18"}. The heavy plant material may limit the Inspectors visual observation of the existing surfaces
- One or more areas of the walls revealed an unknown organic substance.

*Vegetation in contact with structure*

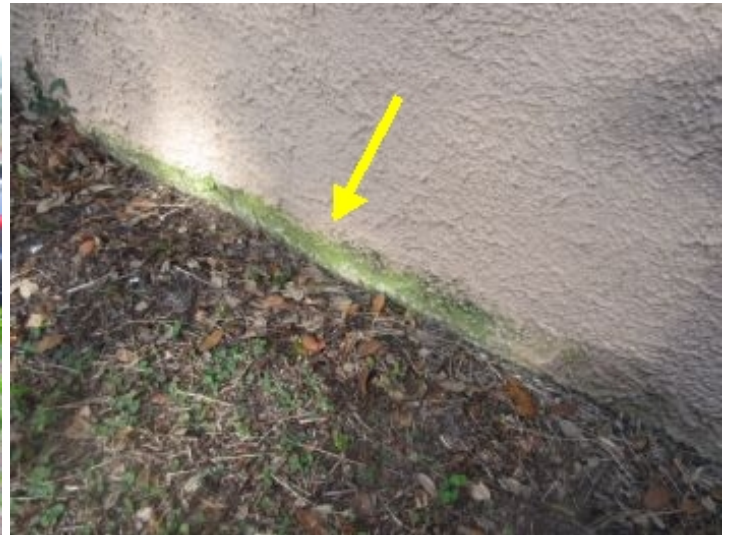
*Unknown organic substance*

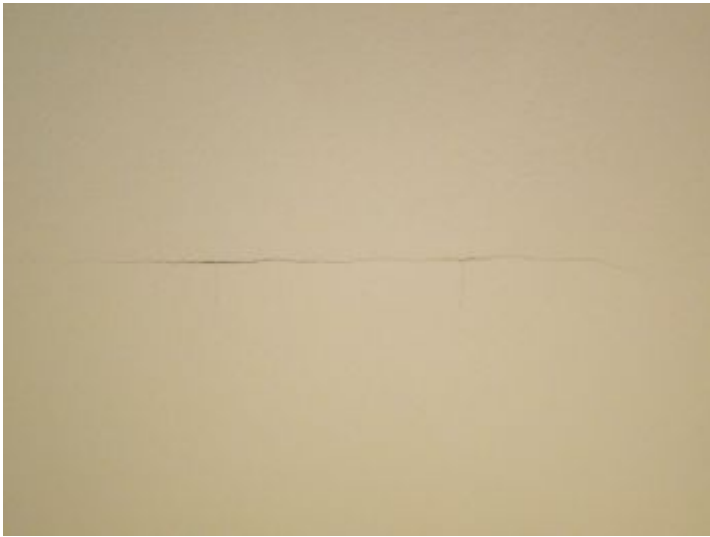
*Small crack in master bed ceiling*

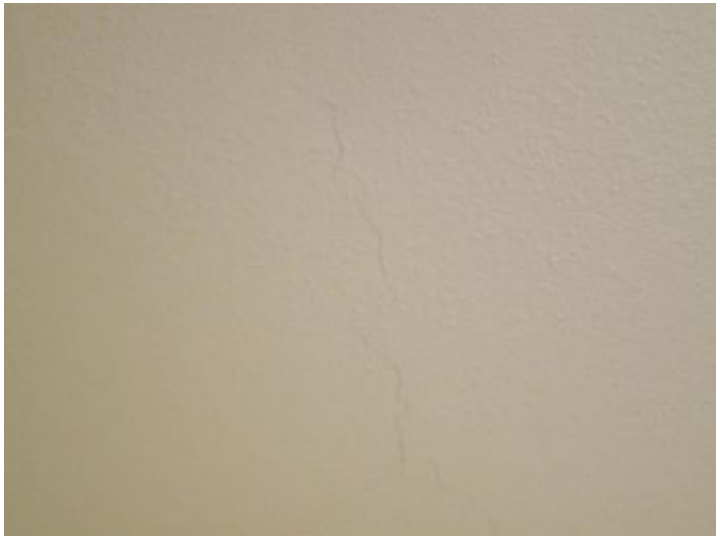
*Small crack in 2nd bedroom ceiling*

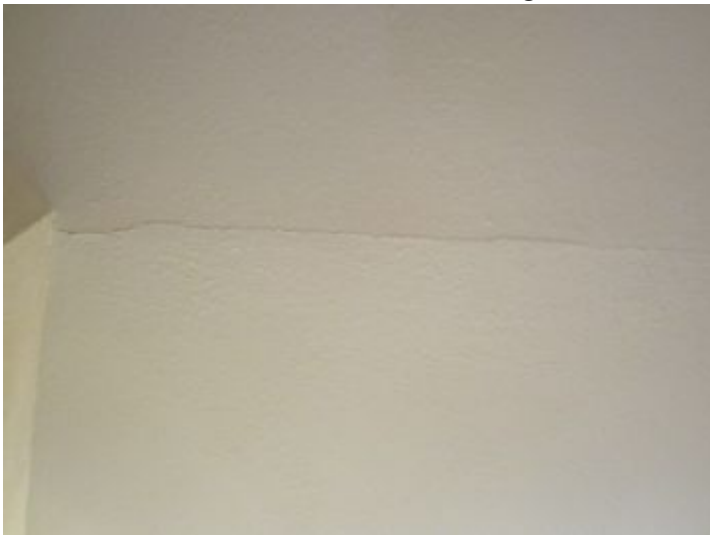
*Small crack in hallway ceiling*

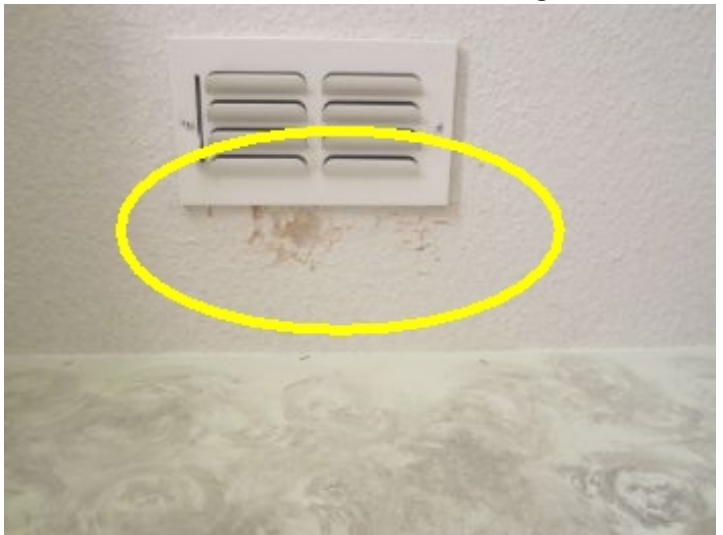
- Minor ceiling stress and/or joint cracks were observed in various locations.
- Water stains were observed on the ceiling of the hallway bathroom. Most likely caused by condensation dripping off the nearby air register. The cause and remedy should be further evaluated and corrected as necessary.

*Water spot in hallway bath ceiling*

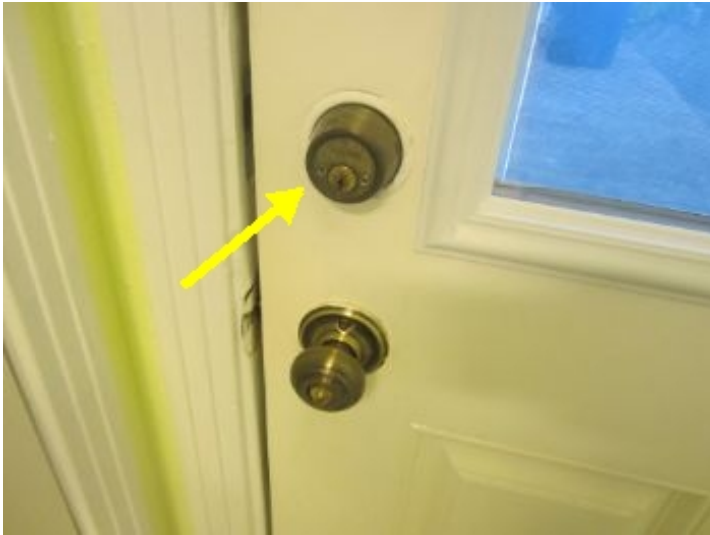
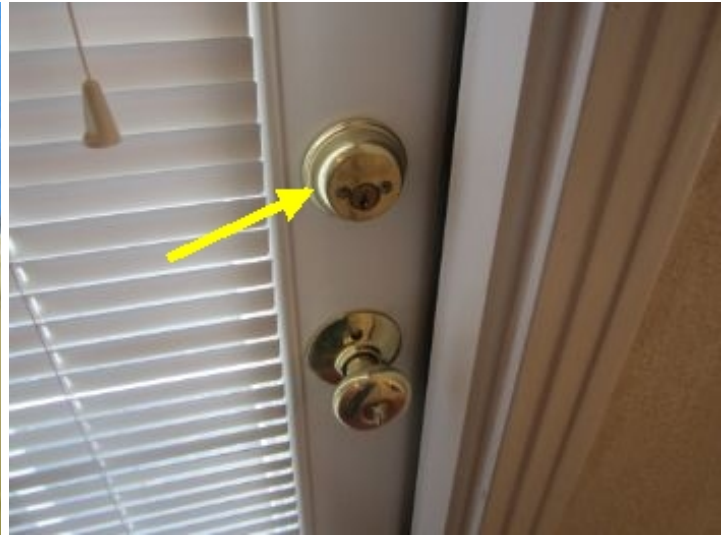
- Double cylinder locks were observed in one or more locations at the egress doors. ALL exterior egress doors should be readily operable from the interior side without the use of a key or special effort and/or knowledge as per current fire safety standards
- Screen door at back porch was damaged.

*Interior keyed dead bolt on egress door*

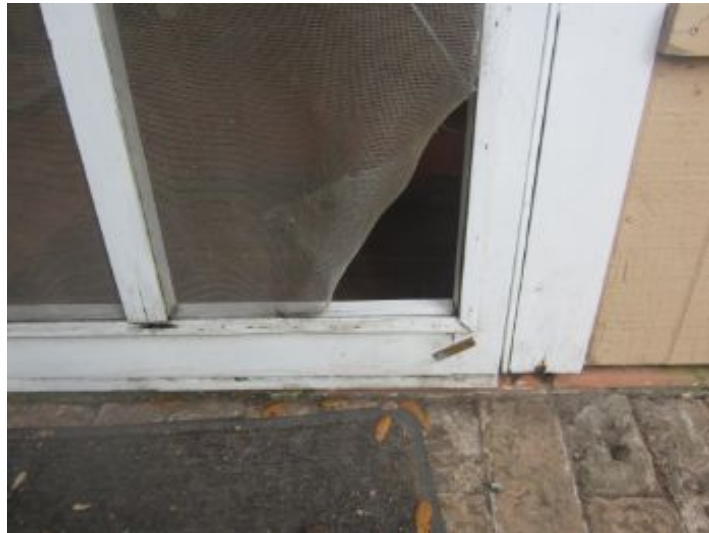
*Damaged screen on rear porch door*

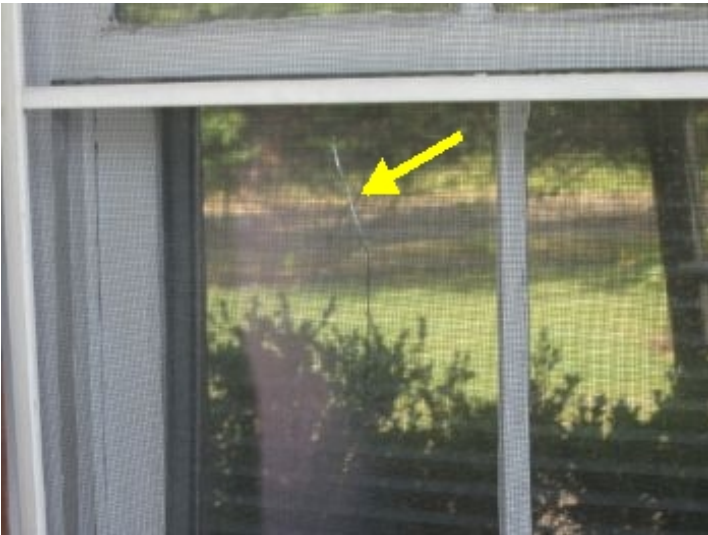
- Cracked and/or broken glass was observed in one or more locations including the front den area window.
- One or more of the window screens were observed to be damaged and/or missing
- The paint on the window sills was observed to be peeling from the bottom at one or more locations.

*Crack in window*

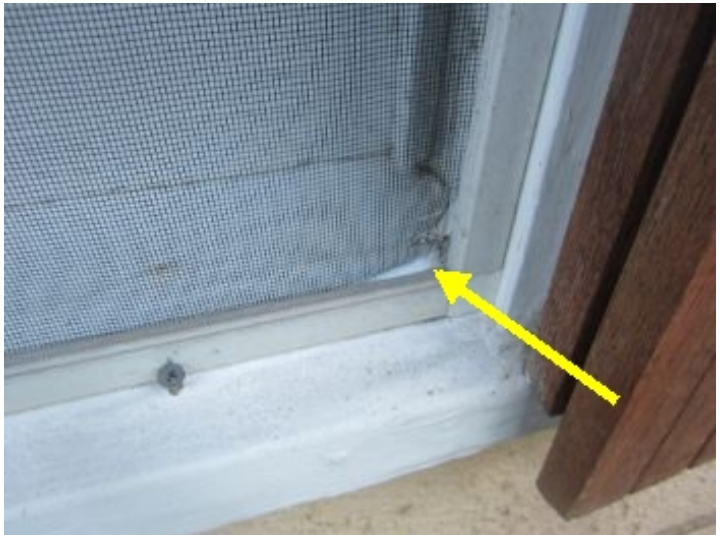
*Damaged window screen*

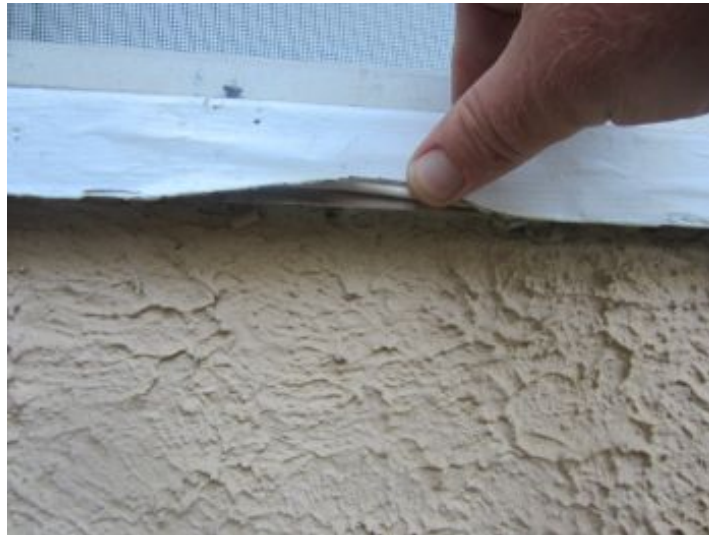
*Paint peeling on window sills*

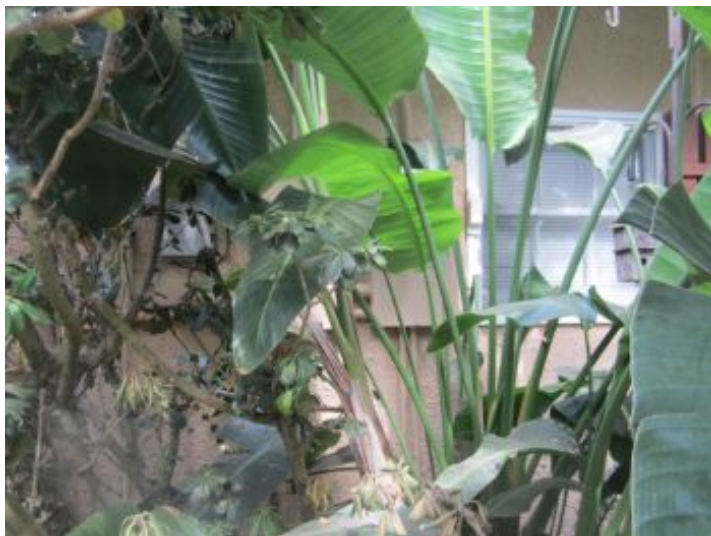
- Improper to access the electrical panel due to heavy vegetation. Ready access to the panels should be maintained in case of an emergency need to shut off the electricity.

*Panels are not accesible*

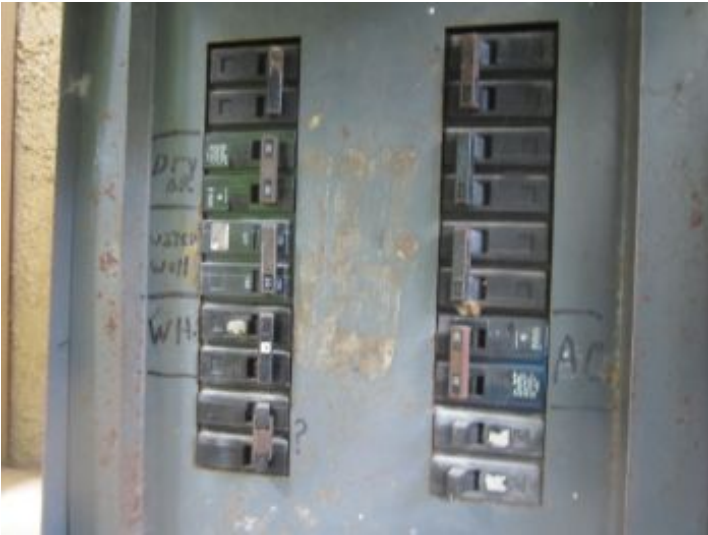
*Breakers not completely and properly labeled*

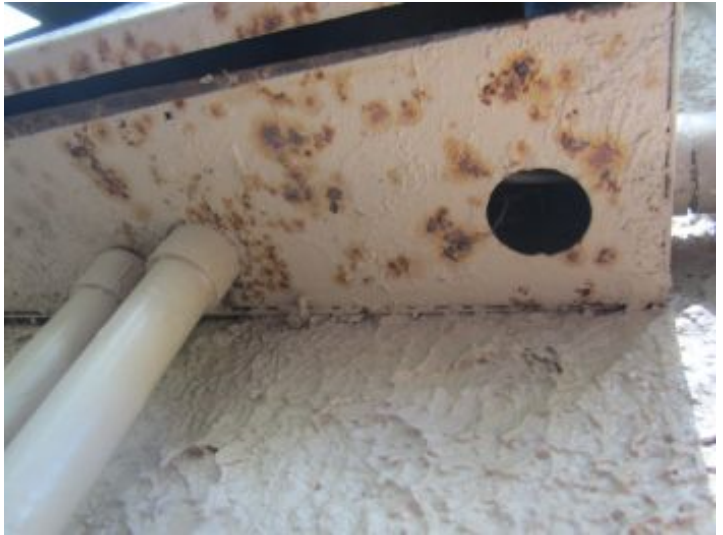
- There is an open knockout hole in the bottom of the panel that needs to be sealed to prevent rodent entry.
- The locking tab on the bottom of the panel is damaged and not functioning properly

*Open knockout at service panel*

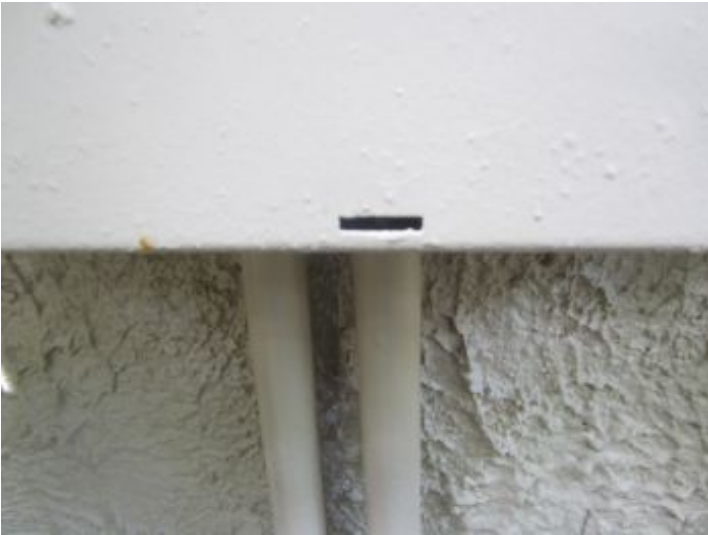
*Broken door latch at service panel*

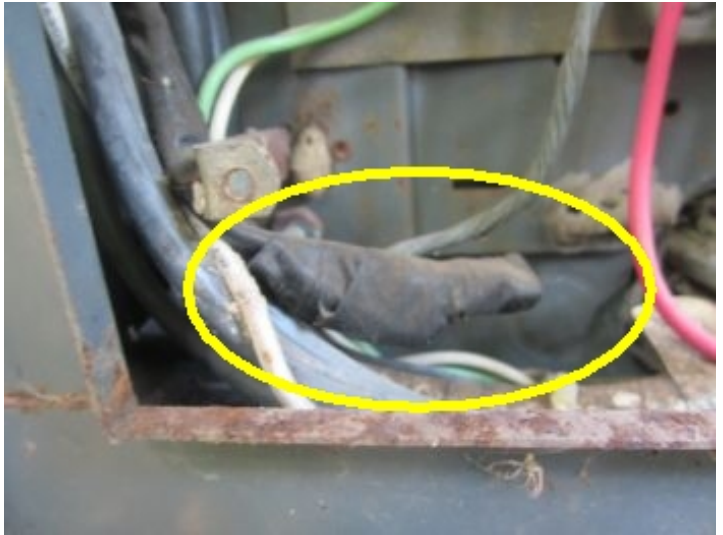
*Taped off wiring inside service panel*

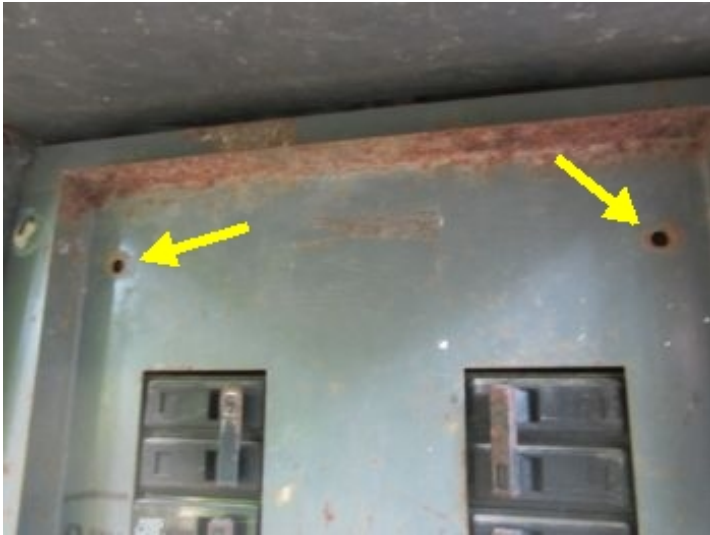
- Panel box cover plate (dead front) is missing one or more screws.
- Screws located in the electrical panels should have a blunt end, rather than a sharp point, to prevent accidental damage to wiring within the panel.

*Missing screws in dead front cover*

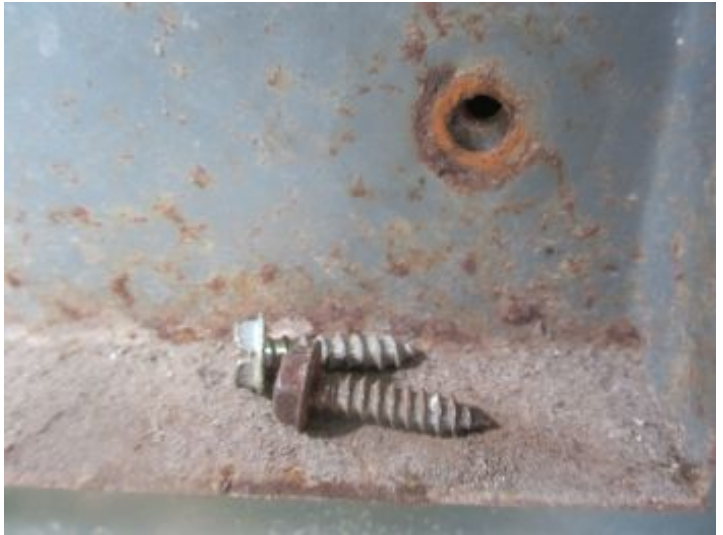
*Improper screw type in panel*

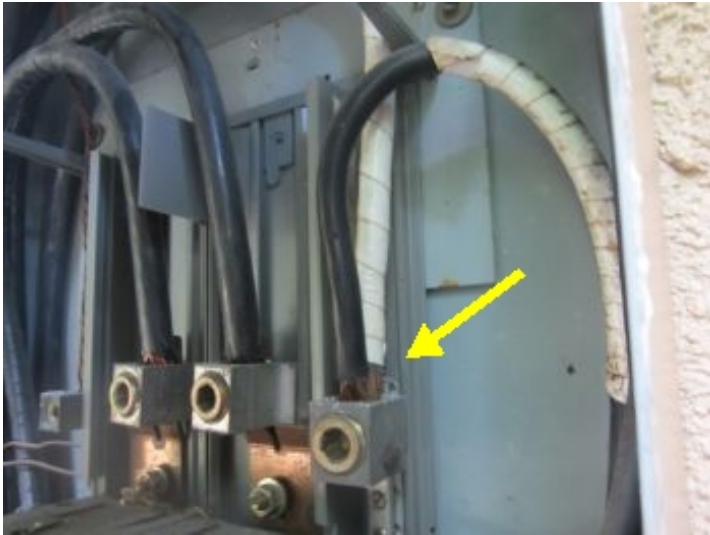
- The neutral lug at the service entrance panel is improperly "jumped" to the second panel next to it. This is indicative of a do-it-yourself type repair. I recommend having a licensed electrical contractor review the electrical system and fix any safety issues.

*Nuetral to second panel is double lugged at main lug connection*

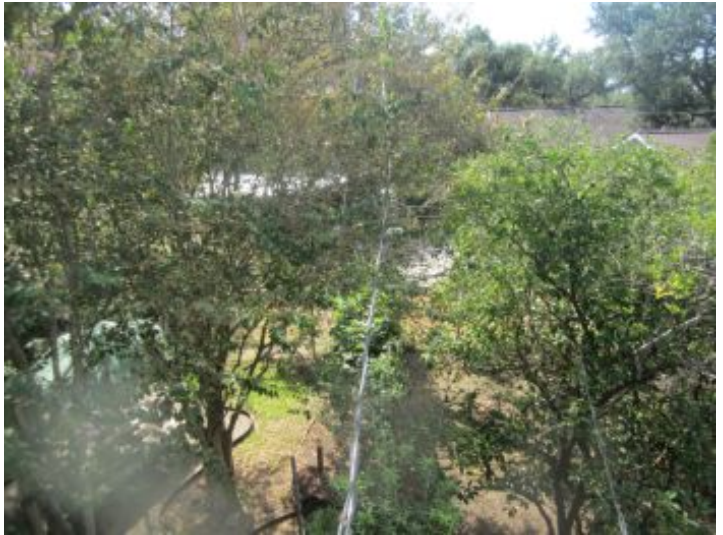
- The overhead electrical service entrance wires are in direct contact with tree limbs in the back yard and trimming is recommended

*Tree branches in contact with service entrance conductors*

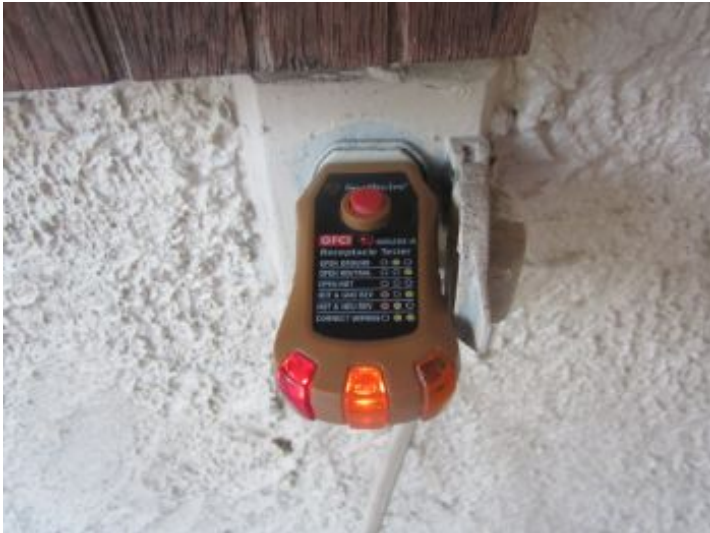
*Hot and neutral reversed on exterior outlet*

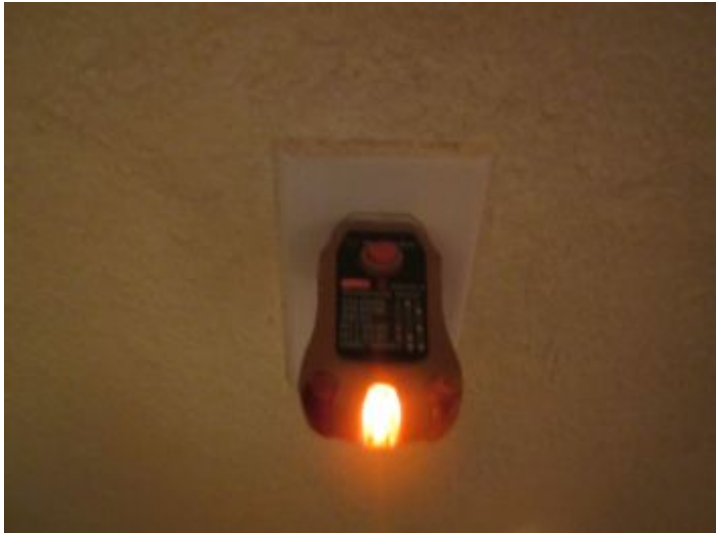
- One or more of the receptacles were noted as an "open ground" and should be corrected
- One or more of the receptacles were noted as "reverse polarity" and should be corrected

*Open ground receptacle*

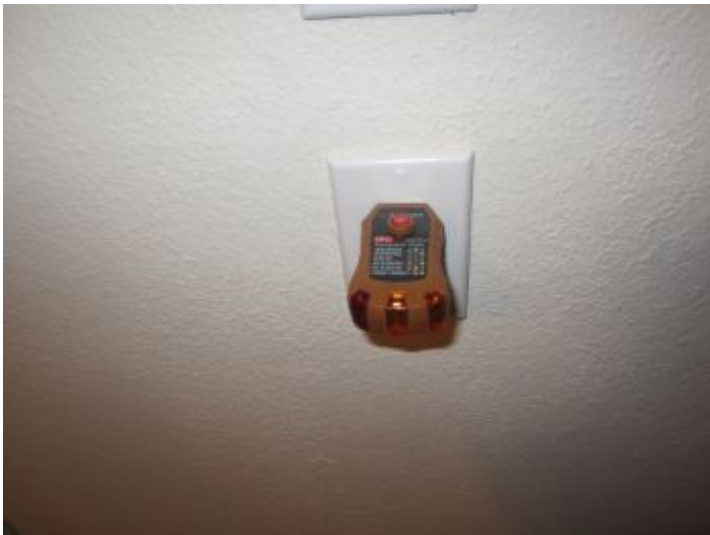
- One or more of the receptacles were noted as "non functional," including the outlets located 3-4ft above the floor in all bedrooms, and should be corrected

*Non-functioning outlet*

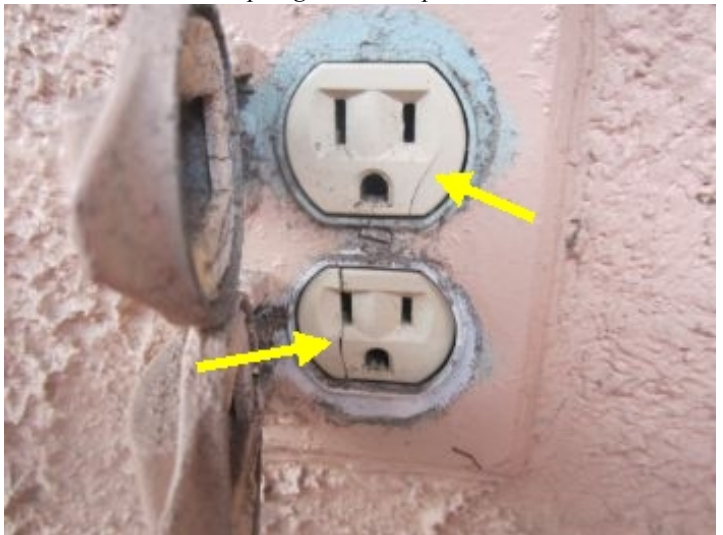
*Damaged receptacle*

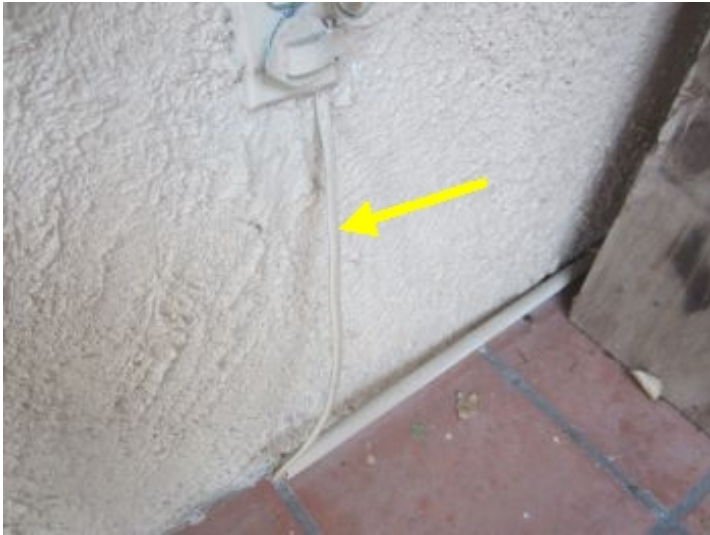
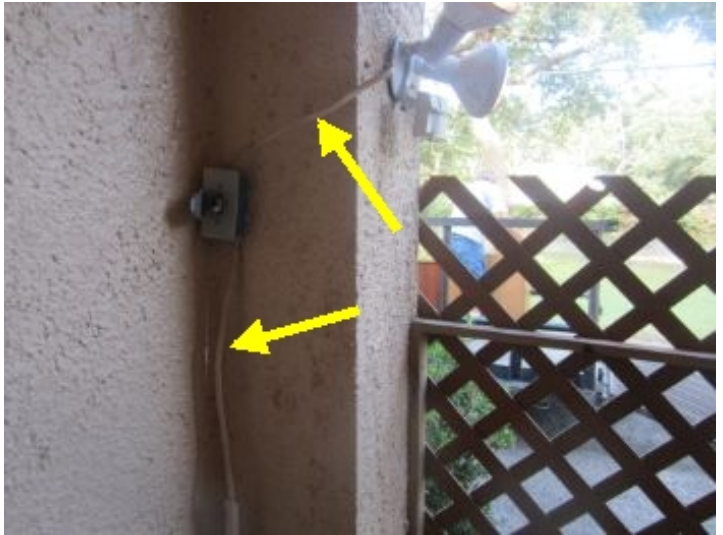
- Damaged/cracked outlets were observed. This situation creates a Safety Hazard and should be corrected.
- Exposed romex type wiring was noted and should be encased in steel pipe or **PVC** conduit raceway

*Romex wiring not located inside conduit*

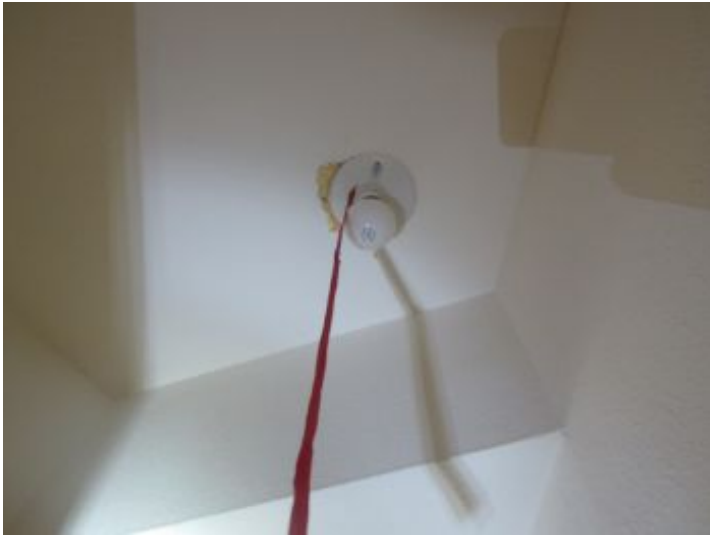
*Unprotected light fixture*

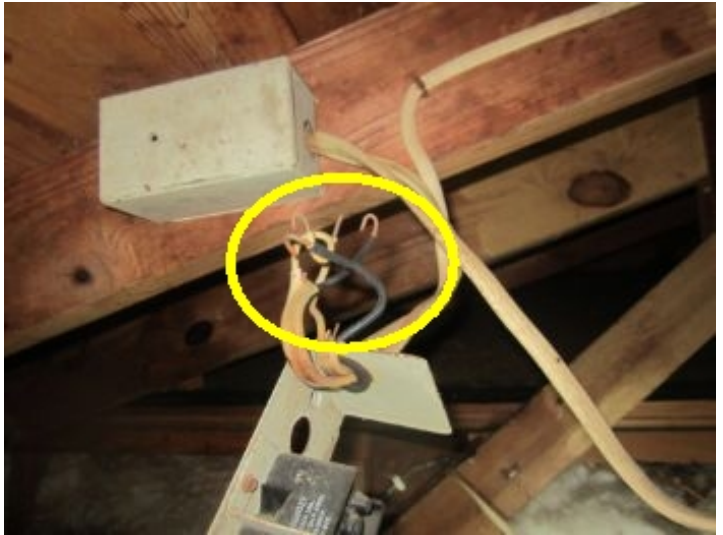
- Unprotected light fixture was observed in the master bathroom closet.
- Some exposed, open ended wiring was observed in the attic area near the **A/C** unit, and should be repaired. Extreme caution should be taken when making repairs.

*Exposed open-ended conductors in attic*

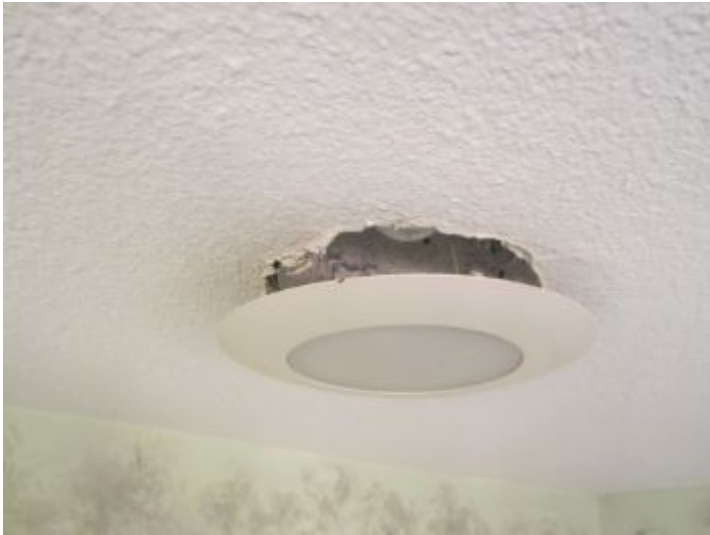
*Loose lighting fixture in hallway bath*

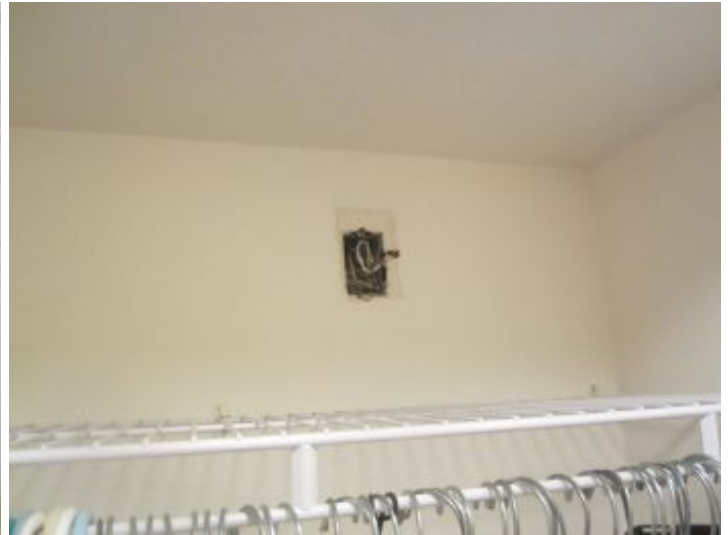
- A loose light fixture was observed in the hallway bathroom above the shower, and should be corrected.
- Uncovered junction boxes were observed in the master bedroom closet and the attic area.

*Open junction box in master closet.*

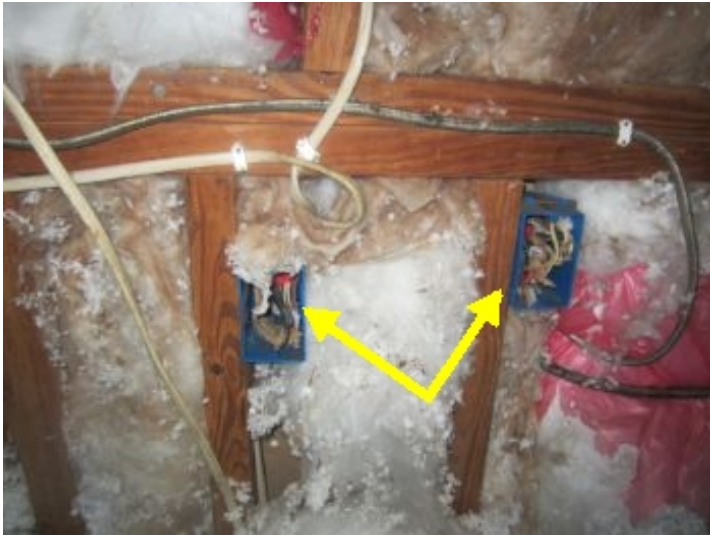
*Open junction boxes in attic*

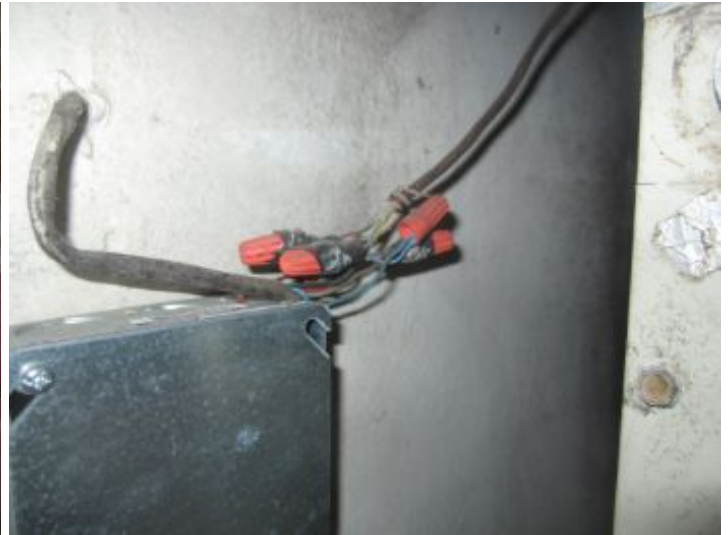
- All wire splices should be located within an approved junction box.
- Inadequate number of wall receptacles in the fourth bedroom. The maximum spacing between wall receptacles is 12ft.

*Wire splices not located in J-box*

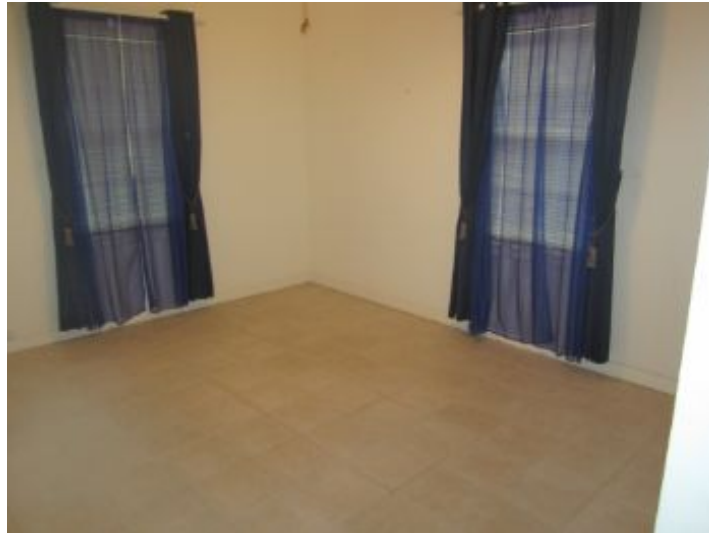
*Inadequate outlet quantity in 4th bedroom*

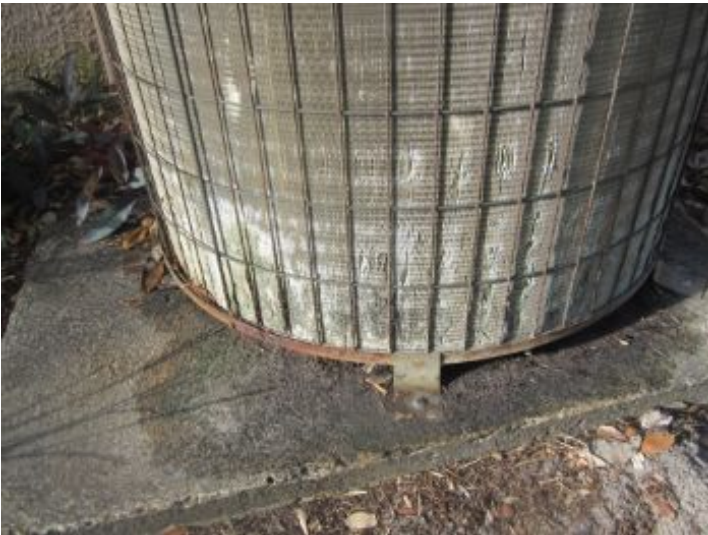
- The north (bedroom side) unit appears to be functioning as intended at the time of inspection and consistent with accepted industry standards.
- The south (kitchen side) unit is not cooling as it should in my opinion. The measured temperature split was 10 degrees (65-75). Common acceptable temperature split is in the range of 14-21 degrees. The temperature split is determined by measuring the temperature of the air entering the air handler at the main return air duct (75 degrees), and comparing that to the temperature of the air coming from the supply registers (65 degrees).
- The north side condenser unit had dirty and/or damaged fins
- The north side condenser unit had rusted fan guard.
- A secondary condensate drain was not visible on the north side A/C unit.

*Damaged condenser fins*

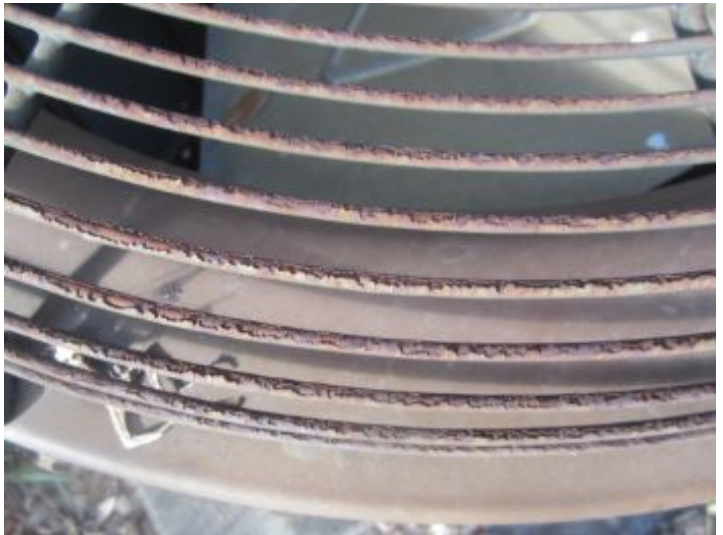
*Rusted fan guard on condenser*

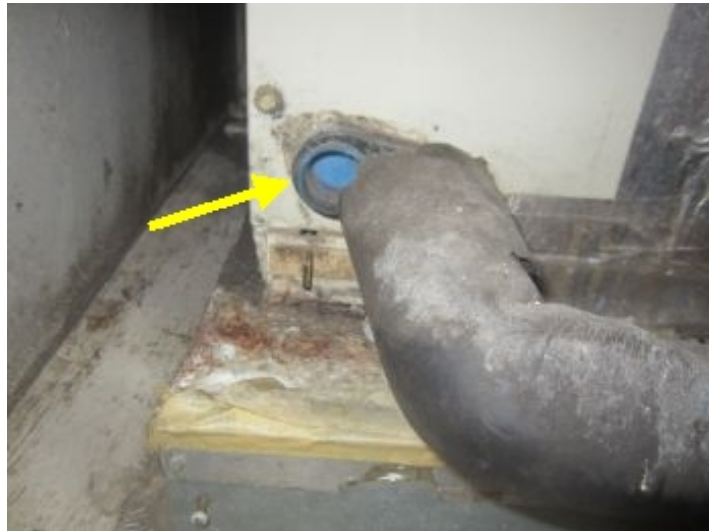
*No secondary condensate drain*

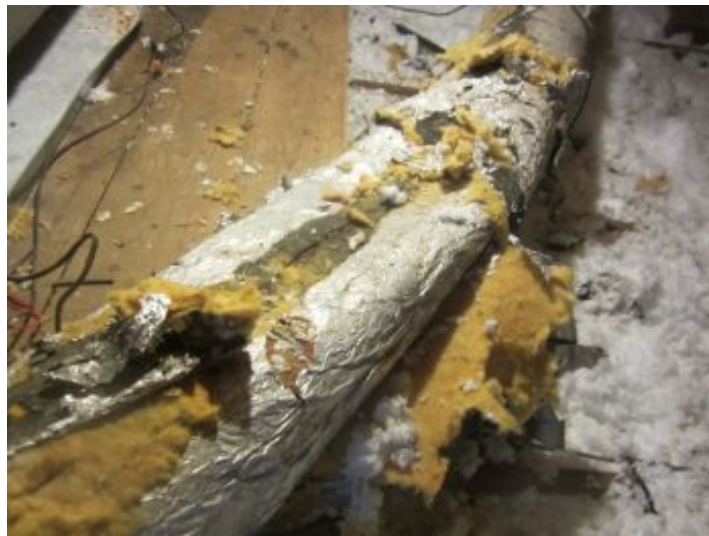
- Visually inspected the accessible areas of the HVAC ductwork only. Recommend replacing air filters upon moving in.
- Metal ductwork was observed
- The ductwork in the attic was observed to have extensively damaged insulation, and was crushed in one or more locations in the attic.

*Damaged vent insulation***IV. PLUMBING SYSTEM**

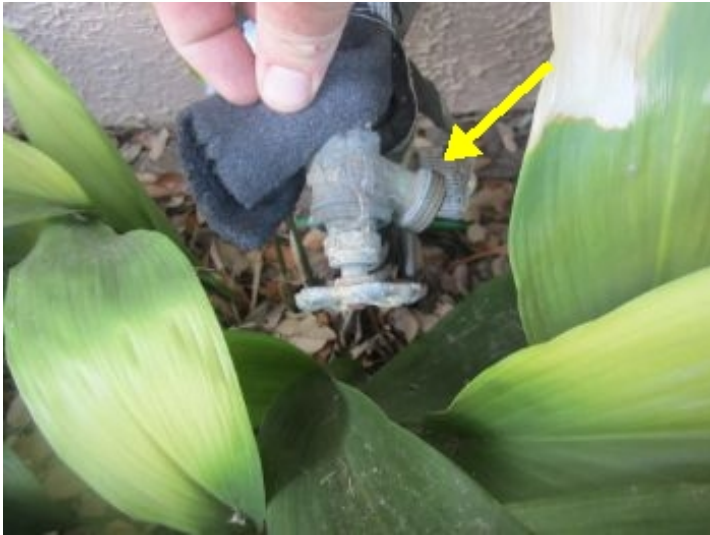
- The anti static water pressure was observed at 50 PSI (acceptable)
- One or more of the exterior water hose bibs {faucets} was not equipped with a back flow and/or anti-siphon {vacuum breaker} device. An anti-siphon device prevents unsanitary water from being pulled back through a garden hose and/or lawn sprinklers and contaminating the household water system
- Sprayer head in the kitchen sink did not self retract. This creates the possibility to siphon water from the sink and contaminate the household water supply.
- Wet bar sink soap dispenser was damaged/broken.

*Missing anti-siphon device*

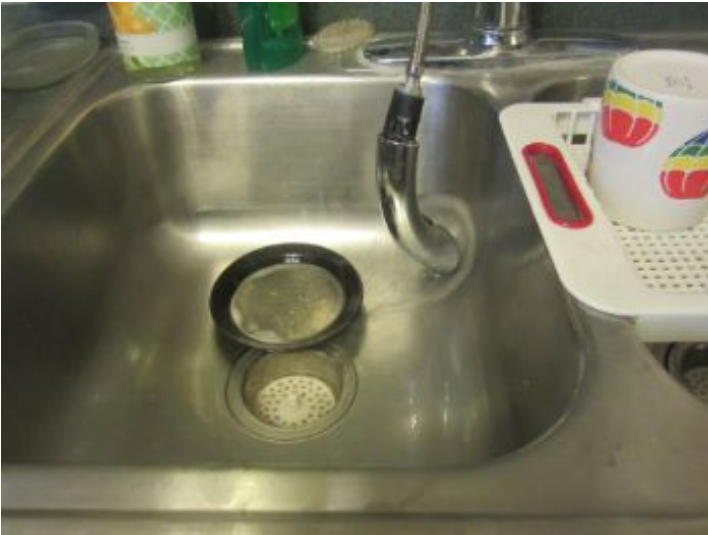
*Sprayer is not self-retracting*

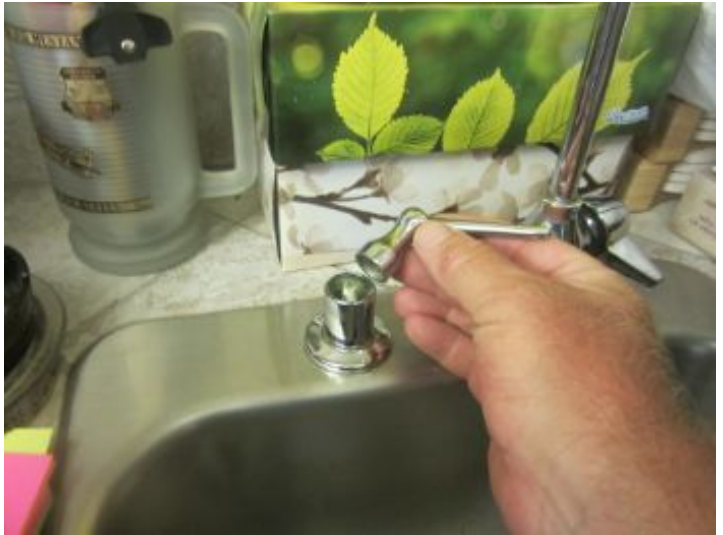
*Broken soap dispenser on wet bar sink*

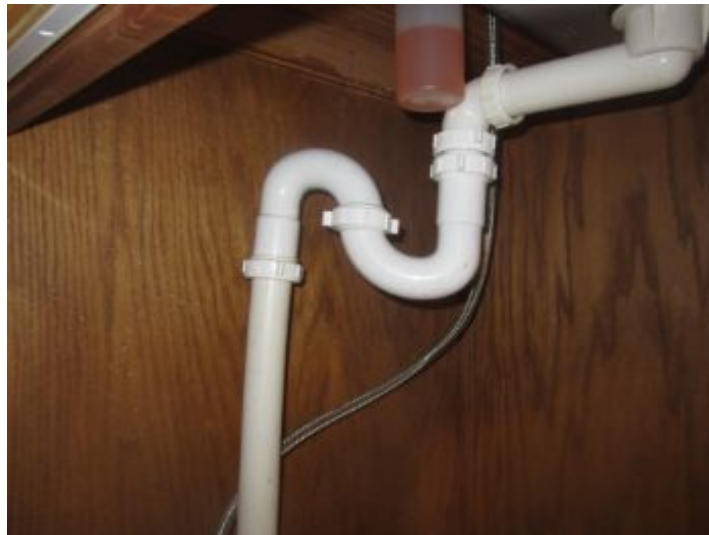
- An "S-Trap" was observed in the drain piping of the wet bar in the dining room area. By today's building standards, "P-Traps" are preferred.

*Outdated S-Trap at wet bar sink*

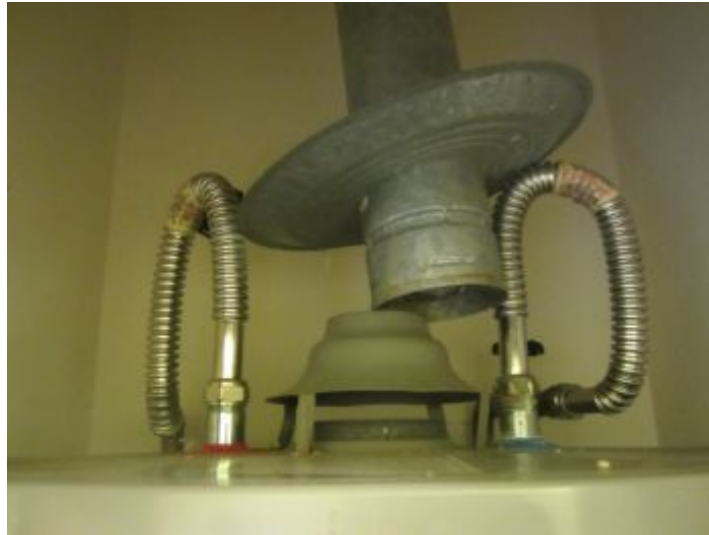
- The vent pipe was disconnected and service is recommended

*Disconnected B-Vent*

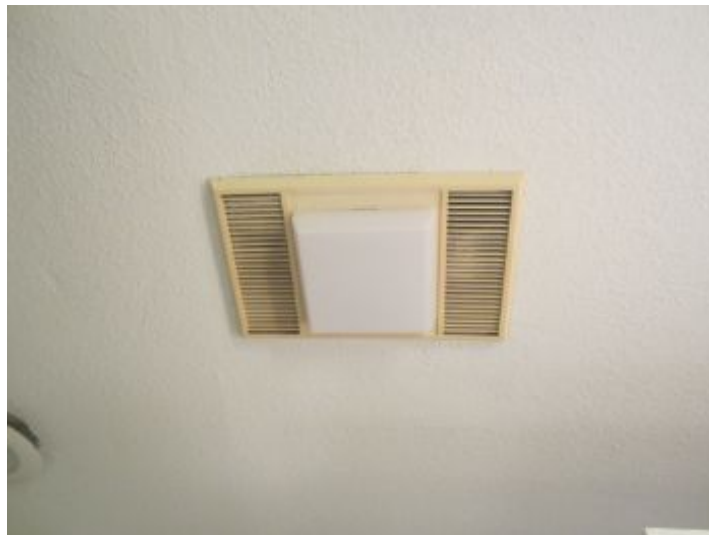
- The bath fan{s} were functioning as intended at the time of inspection
- The light co-installed with the bath fan in the hallway bathroom did not function at the time of the inspection.

*Non-fuctioning light at vent in hallway bath*

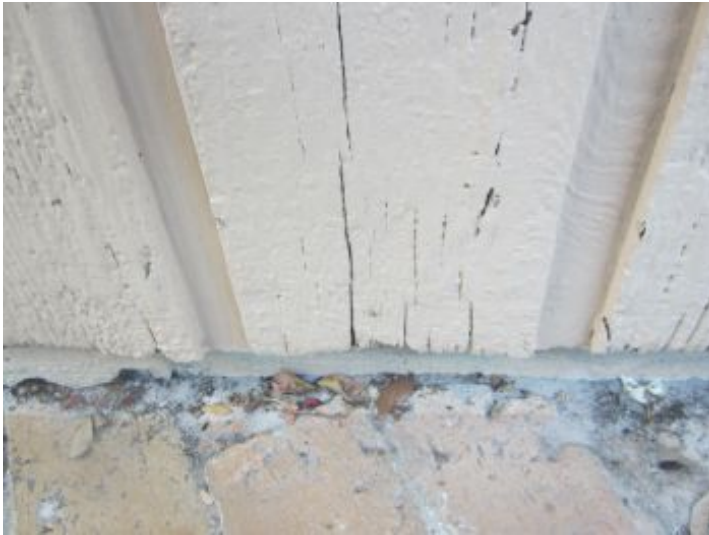
- Wood rot was observed on some of the wood paneling of the detached garage.
- A common occurrence in the Corpus Christi area with slab on grade foundations whether they are with rebar or post tension reinforcement is 'Corner Popping' also called a Corner Wedge Crack. Corner Popping of a foundation is considered a cosmetic, non structural issue until either the concrete of the slab corner starts to deteriorate extensively or the bottom of the corner brick or stone is exposed excessively and/or if there is cracking in the above brick, stone and/or mortar joints above the brick lug of the foundation.

*Wood rot on wood paneling of detached garage*

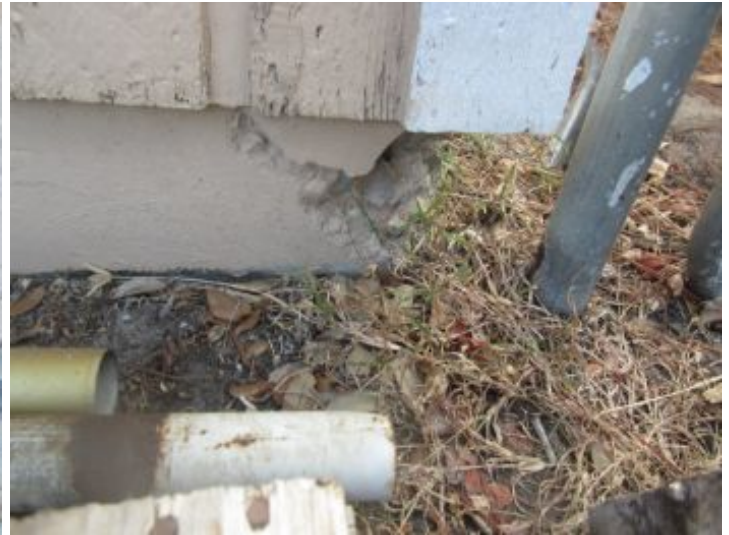
*Foundation corner pop on detached garage*
