From: Matthew Miller <MMiller@ntpc.com>
Sent: July 15, 2021 8:35 AM
To: Brandon Bradbury; David-Scott McQuinn; Ian Ziemann; Clint Ambrose
Cc: Anneli Jokela; Jessica Pacunayen
Subject: RE: Notification of Commencement of Work Under Snare Land Use Permits and Bridge Abutment Work at Snare
Attachments: Left Abutment .jpg; US bin wall filled.jpg; Filling right side.jpg

Subject: Notification of Commencement of Work Under Snare Land Use Permits and Bridge Abutment Work at Snare

The left abutment for the bridge for the Snare site road has lost some of the fill from washout due to high flows through the 5B spillway. Crews on site are going to use material from stockpiled gravel at KM 28, stockpiled rock at Forks Quarry and potentially material from the Snare Falls borrow locations and/or Snare Forks Till pits as required. As required in the permits NTPC will provide amounts for usage under the permit.

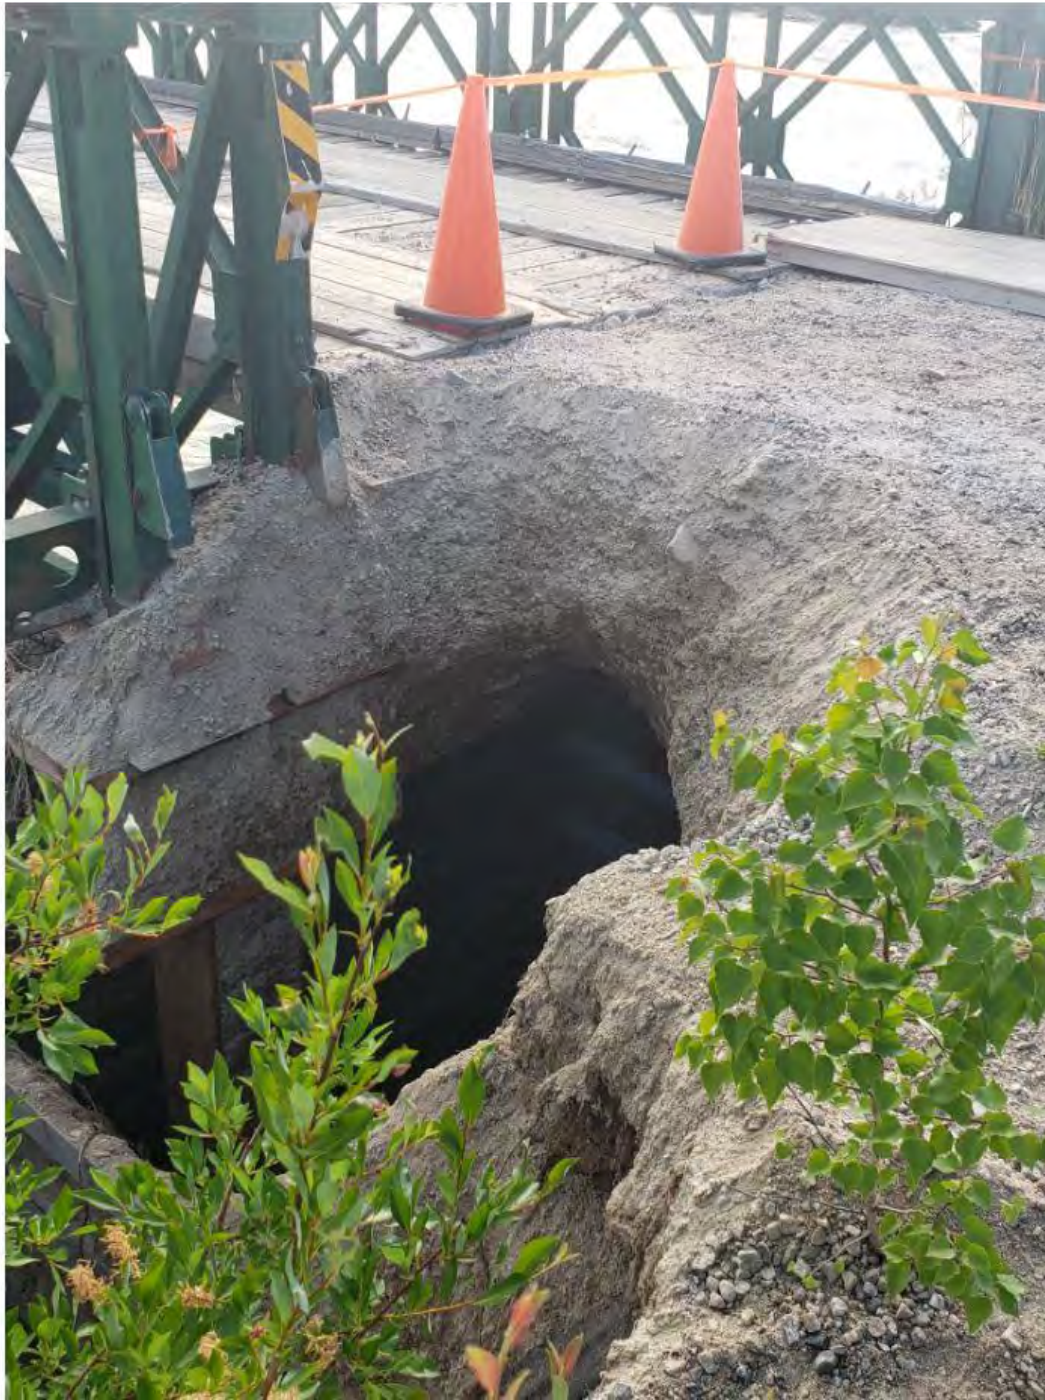
Snare Bridge July 13 1

I have included some photos of the bridge from yesterday evening. The materials on the camp side began to wash out yesterday, and have undercut some of the road surface close to the bridge, most clearly visible in Photo 1. As such the bridge has been reduced to foot traffic only while remediation work is occurring. Rock has been placed in the bin wall on the airport side of the bridge and more rock is being stockpiled along the road, rock was taken from existing stockpiles. More rock will be placed today in the airport side bin.
